# EGR MODULE PTA510-0260

## TECHNICAL INFORMATION

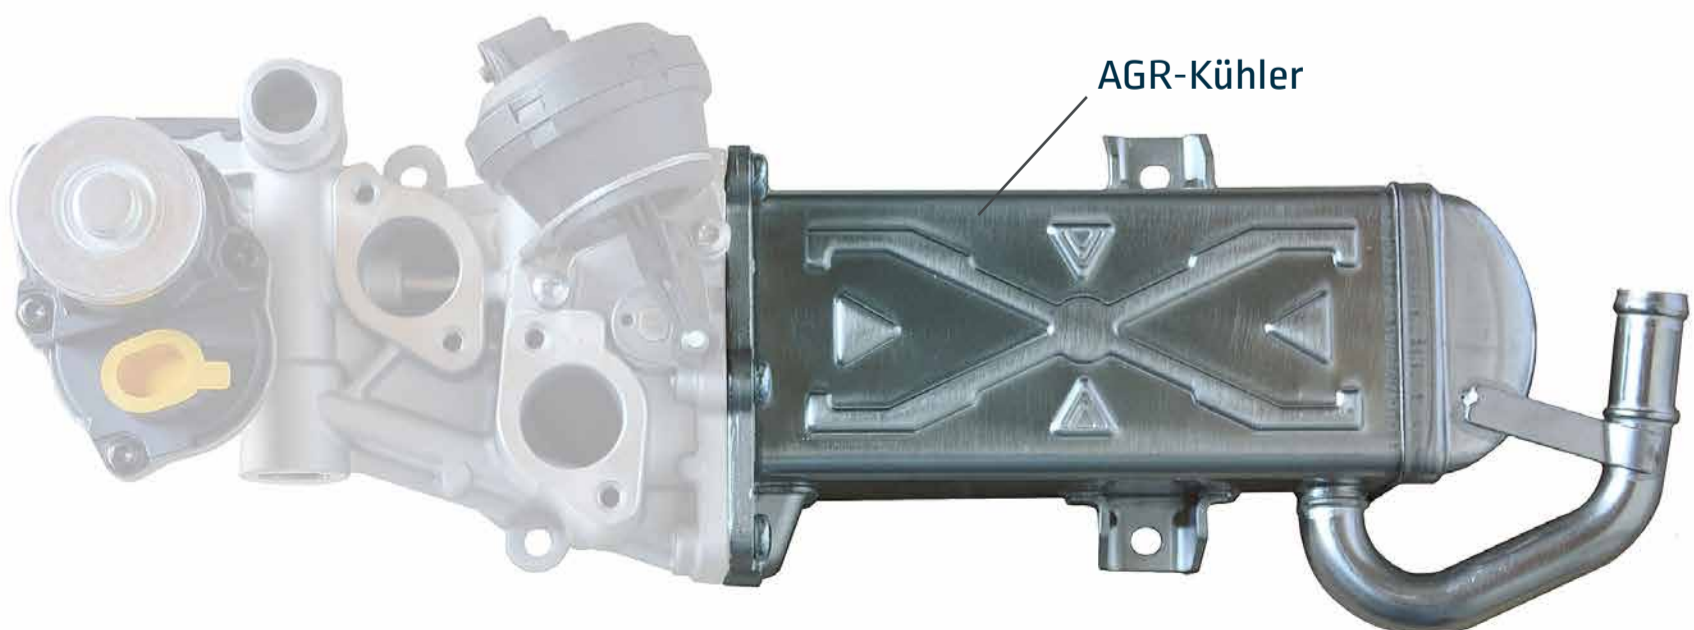
Die Funktion der Zusatzwasserpumpe [OE-Nr: 5N0 965 561] für den Kühlmittelumlauf kann durch einen Übergangswiderstand im elektrischen Leitungsstrang eingeschränkt sein, ohne dass ein Eintrag im Fehlerspeicher hinterlegt ist. Fallweise kann der AGR-Fehlercode P0403 angezeigt werden, obwohl das AGR-Modul funktionsfähig ist. Dieser Fehlercode kann auf eine defekte Zusatzwasserpumpe hinweisen.

Ein Defekt dieser kann eine Überhitzung und damit eine innere oder äußere Undichtigkeit am AGR-Kühler des AGR-Moduls zur Folge haben.

1. Mithilfe der „Geführten Fehlersuche bzw. Stellglieddiagnose“ die Zusatzwasserpumpe für Kühlmittelumlauf ansteuern und prüfen.
2. Den elektrischen, dreipoligen Steckeranschluss der Zusatzwasserpumpe auf Beschädigungen und korrekten Sitz der Pins prüfen. Falls notwendig den Steckeranschluss gemäß Fahrzeughersteller instand setzen.
3. AGR-Kühler des AGR-Moduls auf Undichtigkeit prüfen. Bei Undichtigkeit, AGR-Modul erneuern.

**Bei Auftreten des Fehlercodes P0403 muss eine Überprüfung der Zusatzwasserpumpe (OE-Nr: 5N0 965 561) bzw. die Stellglieddiagnose nachgewiesen werden.**

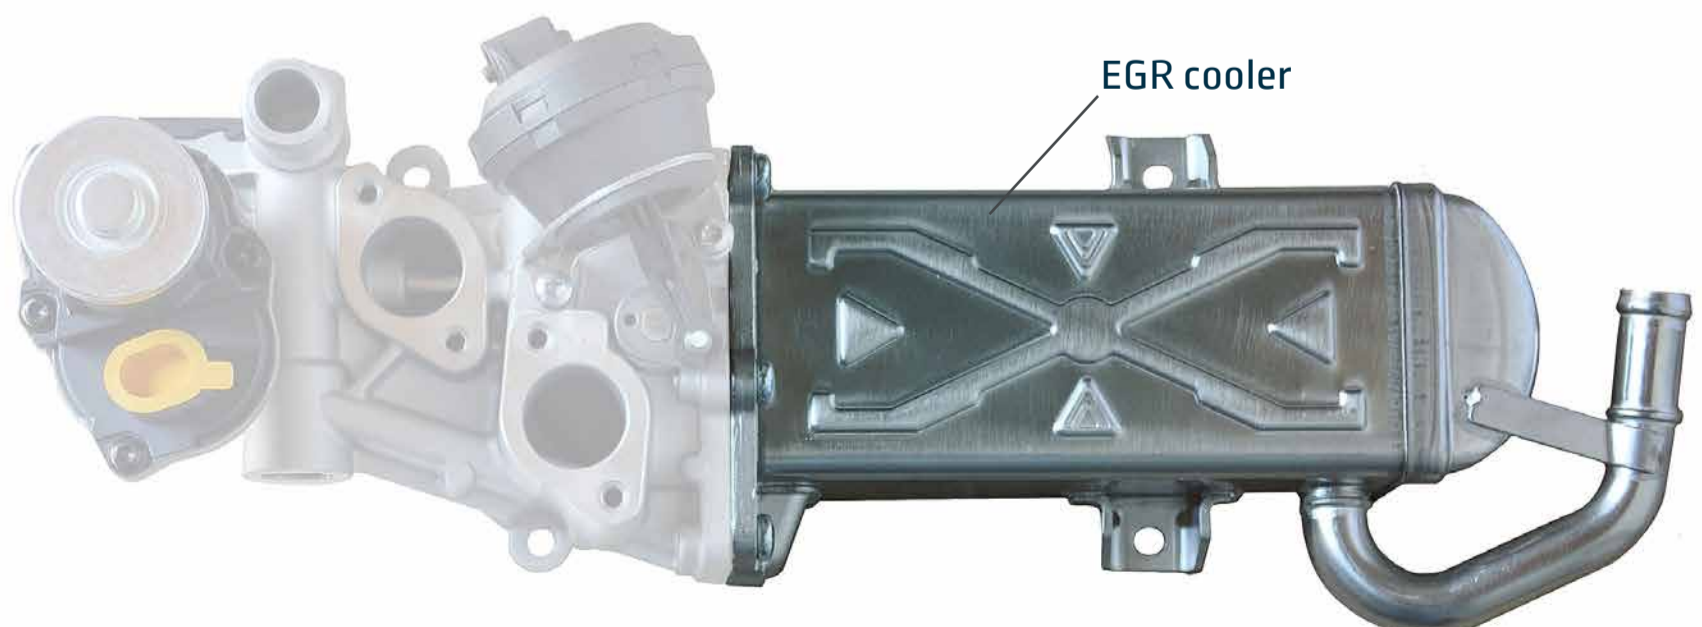
The function of the additional water pump (OE No.: 5N0 965 561) for the coolant circulation may be restricted by a contact resistance in the electrical wiring harness without an entry being stored in the fault memory. In some cases, the EGR error code P0403 may be displayed although the EGR module is functional. This error code can indicate a defective additional water pump.

A defect of this can result in overheating and thus an internal or external leak at the EGR cooler of the EGR module.

1. Use the „Guided search for faults or actuator diagnosis“ to control and check the additional water pump for coolant circulation.
2. Check the electrical, three-pin plug connection of the additional water pump for damage and correct position of the pins. If necessary, repair the plug connection according to the vehicle manufacturer.
3. Check EGR cooler of EGR module for leaks. If leakage occurs, replace EGR module.

**If fault code P0403 occurs, a check of the additional water pump (OE no.: 5N0 965 561) or the actuator diagnosis must be documented.**
