NOCKENWELLENVERSTELLER PTA126-0001

TECHNISCHE INFORMATION ZUM EINBAU

CAMSHAFT ADJUSTER PTA126-0001

TECHNICAL INFORMATION FOR INSTALLATION

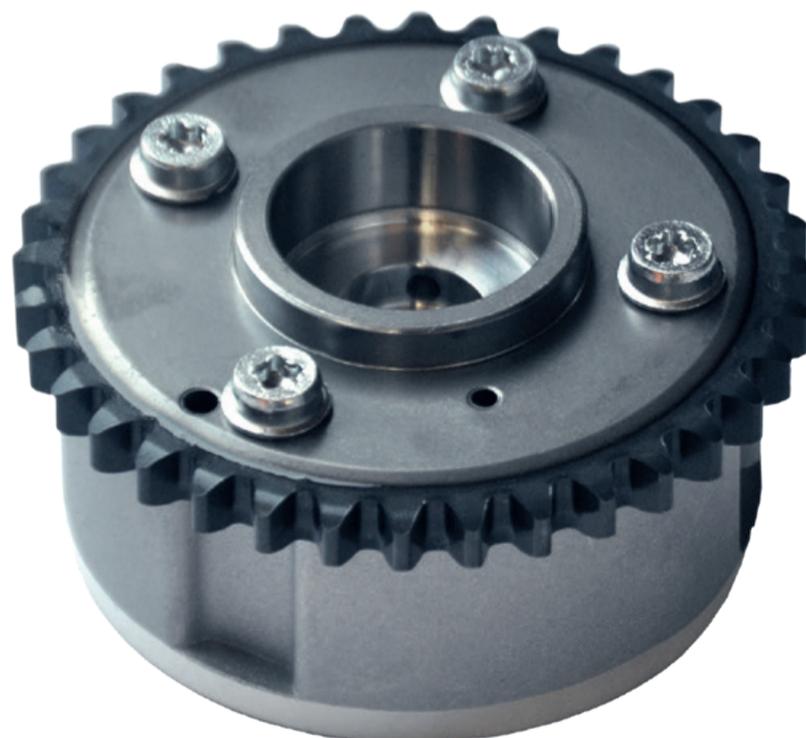
Bei den zugeordneten Fahrzeugen kann es nach dem Einbau eines neuen Nockenwellenverstellers und beim Kaltstart des Motors oder beim Anfahren zu „rasselartigen“ Geräuschen im Bereich des Motors kommen.

Ein Grund kann sein, dass das zugehörige Steuerventil (PTA127-0004) verschmutzt ist und nicht erneuert wurde oder das Steuerventil nach dem Einbau des neuen Nockenwellenverstellers nicht wieder neu am Motorsteuergerät angelernt wurde, was aber für eine einwandfreie Funktion des neuen Nockenwellenverstellers unabdingbar ist.

Es kann dann zu einem „Kettenrasseln“ führen, welches unweigerlich zu vorzeitigem Verschleiß [Längen!] der Steuerkette sowie der Kettenräder und des Kettenspanners zur Folge hat.

Im schlimmsten Fall kann ein Motorschaden entstehen!

Der Fahrzeughersteller schreibt vor, dass der Nockenwellenversteller bei den Steuerkettensätzen PTA114-0021, -0231 und -0232 mit zu erneuern ist!

Es ist zudem empfehlenswert, dass das Motorsteuergerät nach dem Austausch des Nockenwellenverstellers ein aktualisiertes Software-Update erhält.

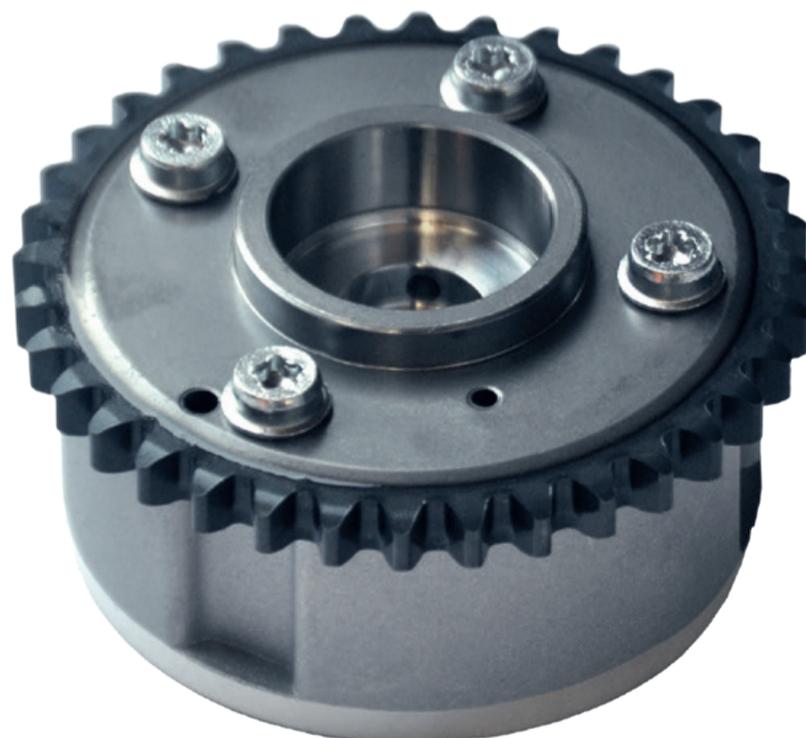
For the dedicated cars it can happen that after assembly of a new camshaft adjuster and at the cold starting phase of the engine „rattling“ noises occur during start-up of the car in the environment of the engine.

A reason could be that the related oil control valve is polluted and was not replaced or that the oil control valve after assembly of the new camshaft adjuster was not readapted to the electronic control unit (ECU). But it is essential for a correct function of the new camshaft adjuster.

It could lead then to a so called „chain rattling“, which causes without fail an early wear (elongation!) of the timing chain as well as of the sprockets and of the chain tensioner.

In the worst case an engine damage can be arisen!

The car manufacturer instructs that the camshaft adjuster for the timing chain kits PTA114-0021, -0231 und -0232 has also to be replaced!

Furthermore it is recommendable that the electronic control unit (ECU) receives an update of the software after assembly of the camshaft adjuster.
